## Explosions Involving Nonconductive Flammable Liquids

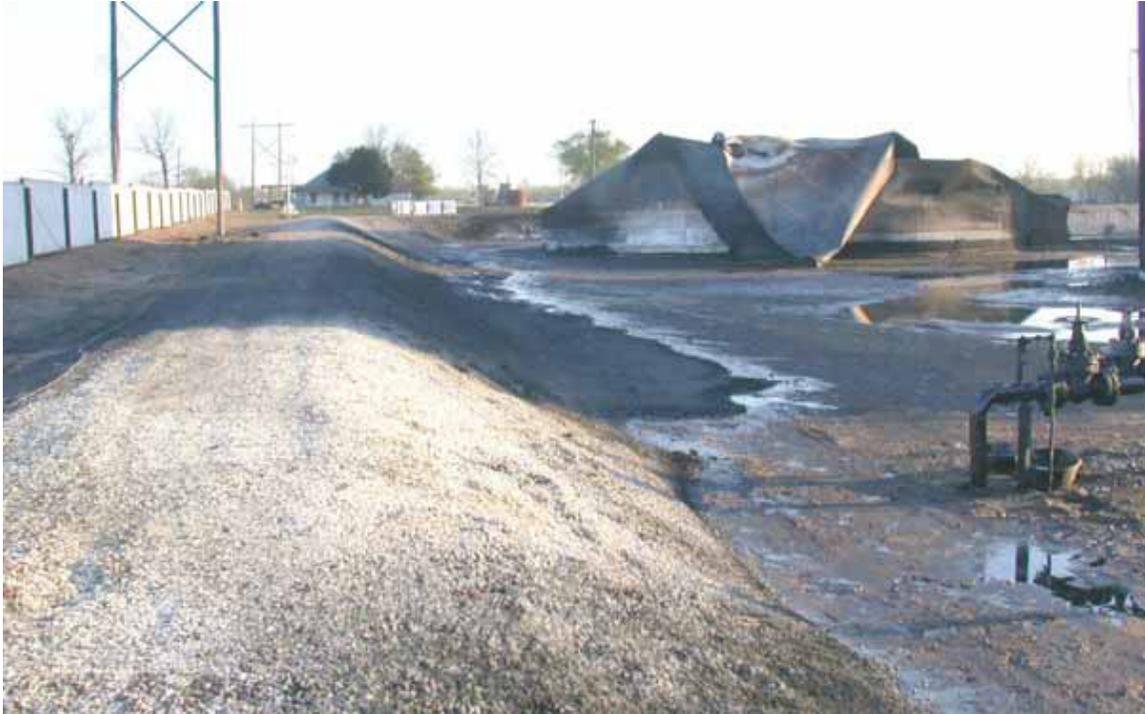
According to the NTSB report, the specific cause of the explosion and fire was a buildup and discharge of static electricity that ignited a flammable fuel-air mixture within the tank being filled. The NTSB report claimed that the tank was being filled at flow velocities significantly higher than that recommended both by the company's own procedures and industry-recommended practices, and this resulted in the buildup of excess static electricity. There was also some blame cast to American Electric Power employees who failed to recognize the risk the tank fire posed to nearby power lines and take effective emergency action.

The NTSB report stated that the high velocity of the diesel in the tank fill piping and the turbulence created in the sump area resulted in the generation of increase static charge and, combined with the very low electrical conductivity (static accumulating) liquid (the diesel fuel), there was an elevated risk for a static discharge inside the tank. (from "Conclusions", page 39 of report).

NTSB calculated that the fill velocity for tank 11 was exceeded by a factor of four.

Figure 1. General View of site several days after accident (note water from firefighting) looking south, tank 11 wreckage at right center, earthen dike at left center, AEP transmission lines at left, photo from NTSB report.

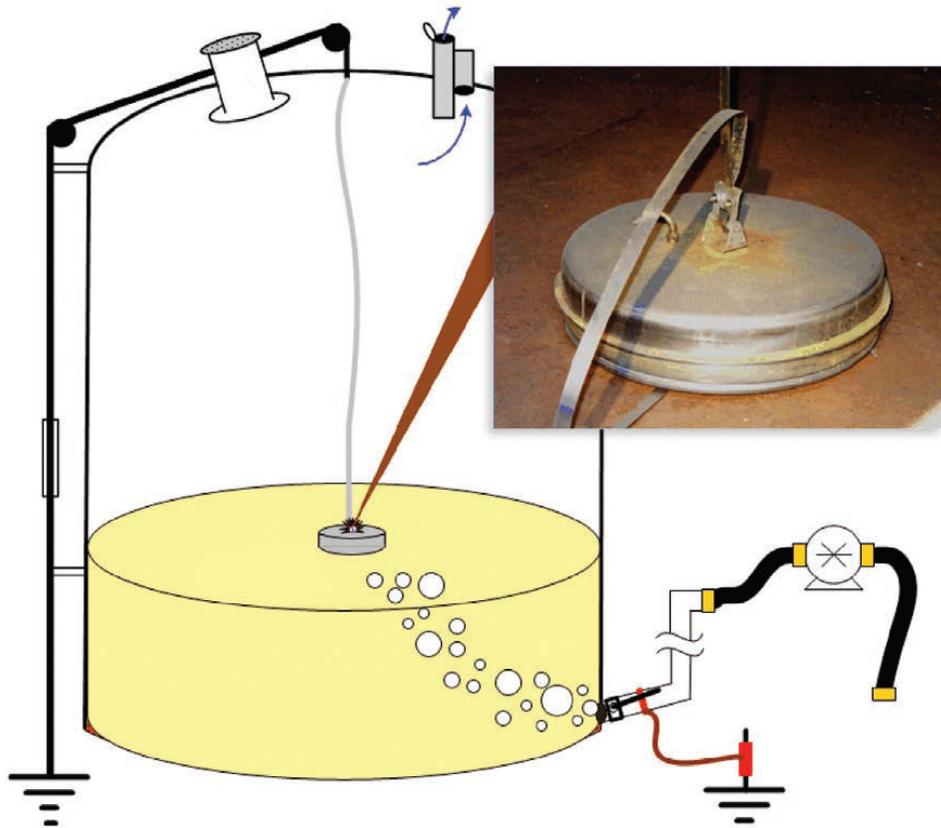
The CSB report concluded that a static spark occurring within the 15,000 gallon storage tank as it was being filled ignited the vapor in the air space above the liquid. The CSB investigation concluded that the transfer equipment from the truck tanker to the storage tank was properly bonded and grounded to prevent the generation of static electricity. However, the float device inside the 15,000 gallon storage tank presented a hidden danger. The static spark was generated from a loosely-linked level-measuring float within the tank. The spark ignited the air-vapor mixture inside the tank as it was being filled.

The CSB determined that the liquid flow and turbulence created by filling the tank likely resulted in the metal float accumulating a static electrical charge. As the float moved, a gap is believed to have formed with the linkage of the tape and the float. A spark likely jumped between the metal parts and ignited the explosive mixture of vapor and air that had accumulated above the liquid.

Figure 2. Chemical Safety Board sketch of the 15000 gallon storage tank during filling showing grounding of the tank and transfer line (lower right), but no grounding of float device (with photo insert of float device).

- The tank, transfer lines, pump, floats, etc. must be properly bonded and grounded. Inspect and replace, as appropriate, floats with level measuring devices which will not promote sparks inside the tank [from CSB report on Barton Solvents explosion].

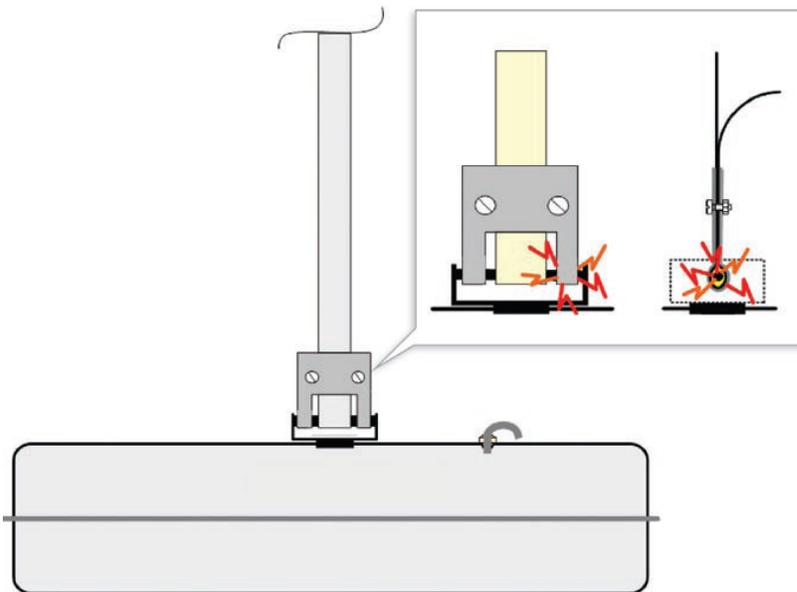
The loose linkage at the float/tape junction separated slightly, interrupting grounding, and created a potential for spark (figure 3). The turbulence created during tank filling caused rapid static charge accumulation, and also created slack in the gauge tape connected to the float (more details in CSB report).

Figure 3. Chemical Safety Board sketch of Float Linkage with front and side view insert where spark likely occurred (in red).
