Propane Fires and Explosions

Turkey Farm, Albert City Iowa, 9 April 1998. Two fire fighters killed, seven injured

Propane Explosion, 30 January 2007, Ghent WV, Four killed including two responders, six injured

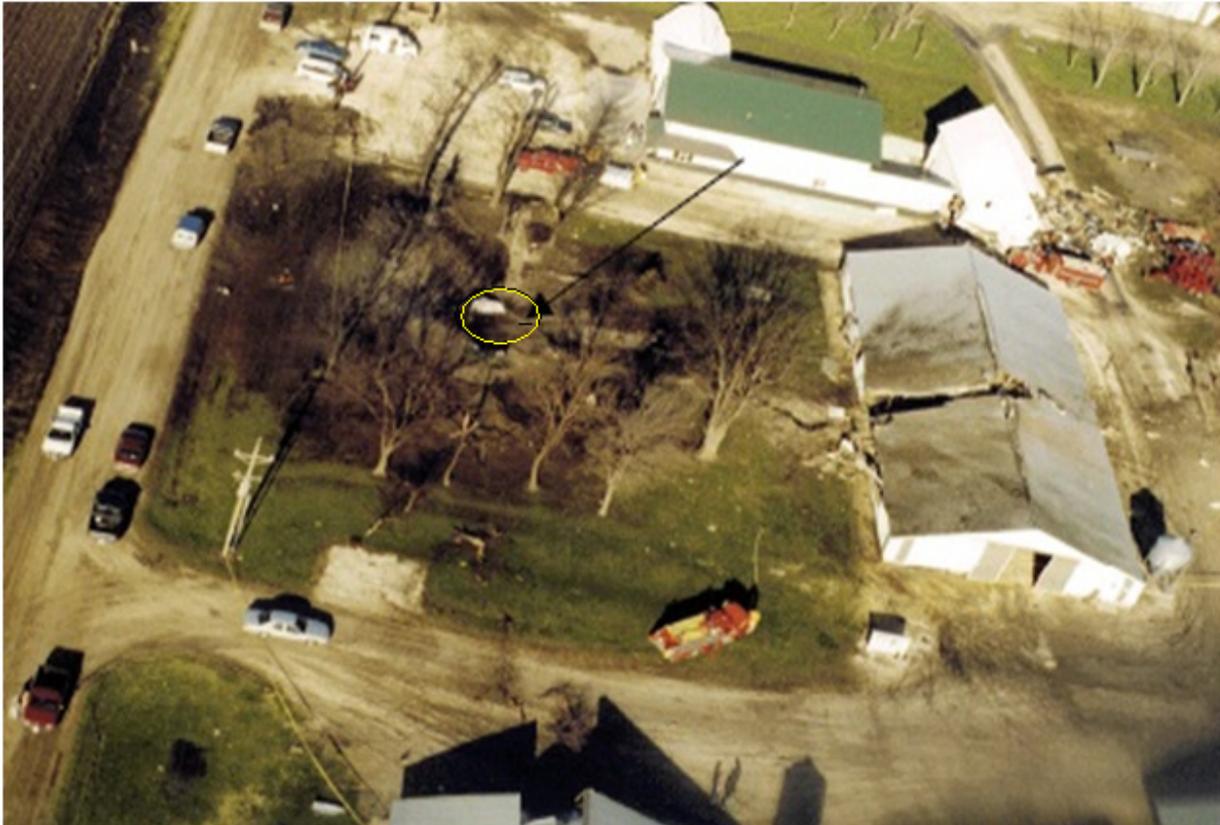
Aerial photo of Herrig Brothers farm taken on 10 April 1998, one day later. Yellow oval shows the location of propane tank prior to the blast (photo from CSB).

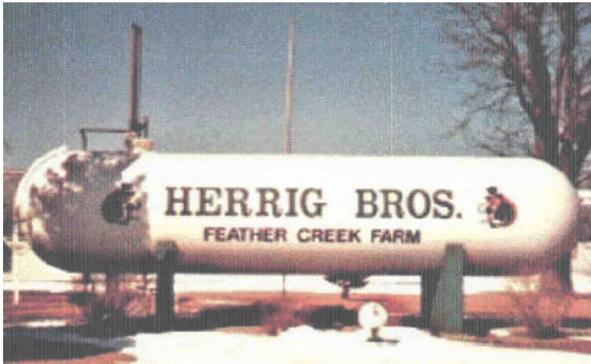
Left, Herrig Bros. 42-foot long tank before explosion. The tank was out in the open away from any buildings, and the tank and above ground piping had no protective fence to keep intruders away. Right, large tank fragment, about half of the tank, was propelled inside a turkey barn as a result of the explosion.

1. The above ground piping was not protected from potential damage by vehicles, as required by Iowa law citing the 1979 edition of the National Fire Protection Association’s “Standard for the Storage and Handling of Liquefied Petroleum Gases” (NRPA 58). The lack of piping protection allowed the ATV to crash into the pipes that ran from the tank to the vaporizers.

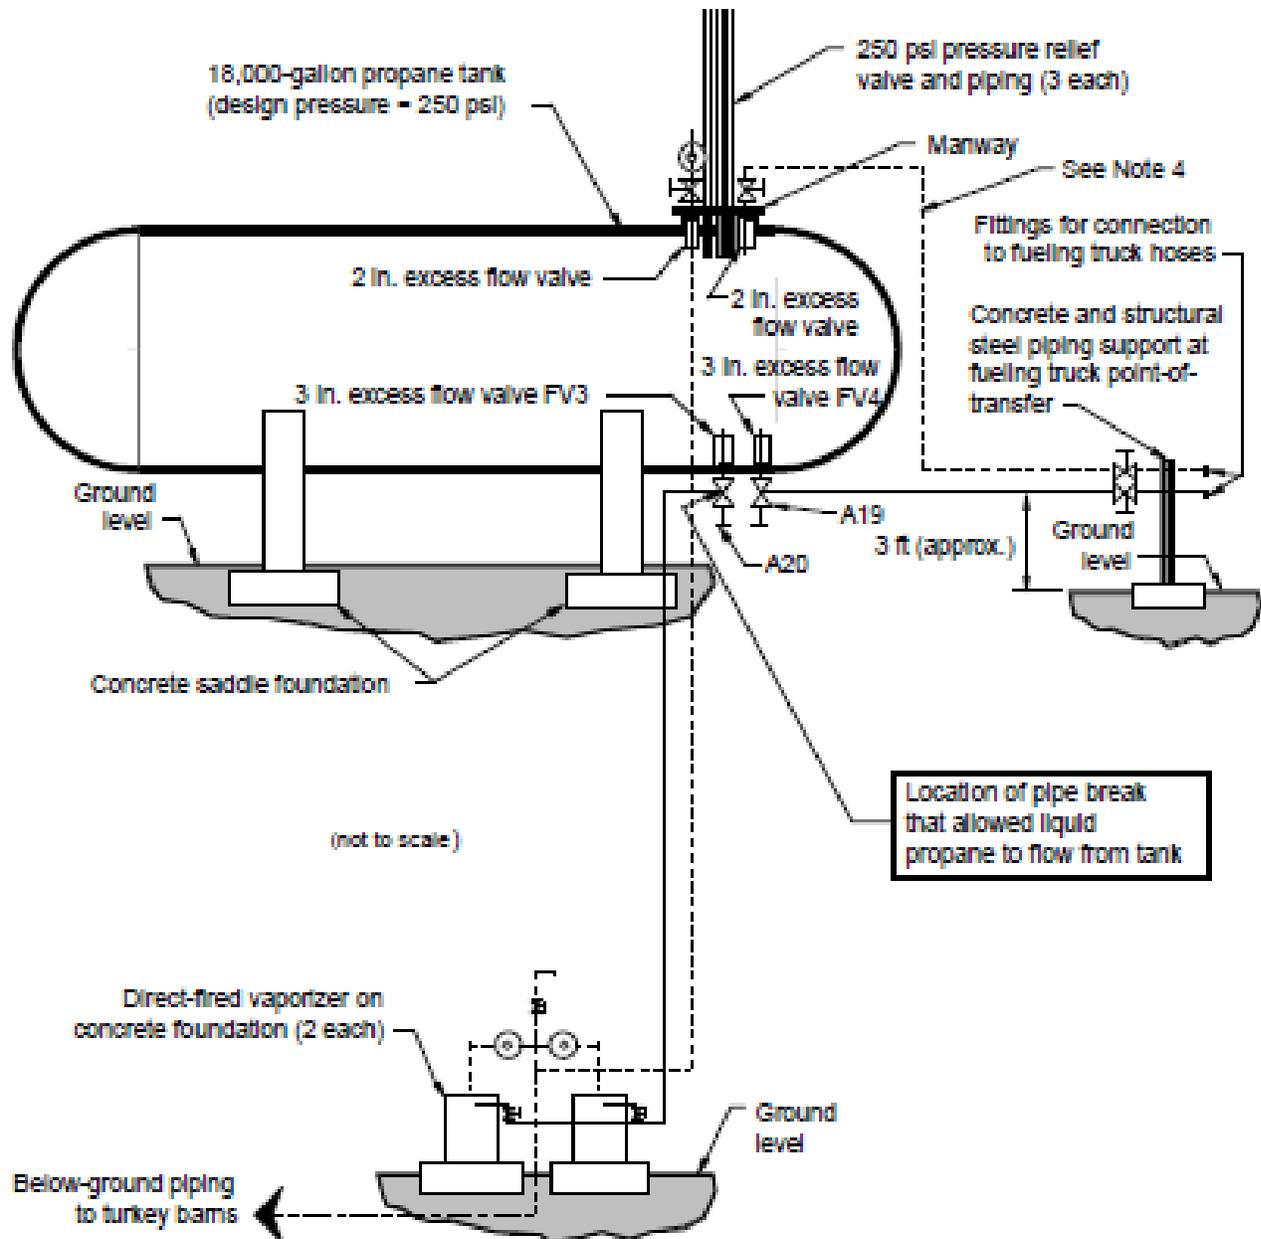
The following is a sketch of 18,000-gallon propane tank and piping setup at the farm, from the CSB report. The tank was estimated to contain 10,000 gallons of propane at the time of the explosion, at approximately 11:28 pm, on April 9, 1998. Two firefighters responding to a fire which engulfed the propane tank, were killed by tank fragments resulting from a BLEVE explosion (BLEVE= Boiling Liquid Expanding Vapor Explosion). Seven other people were injured, and several buildings were severely damaged by the blast. The firefighters assumed if they stayed away from the ends of the tank they would be “safe”, but exploding tank fragments were hurled in all directions.

2. The outlet propane pipe diameter was improperly sized for the excess flow valve, which was supposed to automatically shut off the flow in case of excess flow in the propane pipe. The valve was designed to shut off at 200 gpm, which in no way could occur with the ¾ inch diameter propane outlet pipe. Therefore the valve did not shut off. Had the valve shut off, the BLEVE probably would not have occurred.

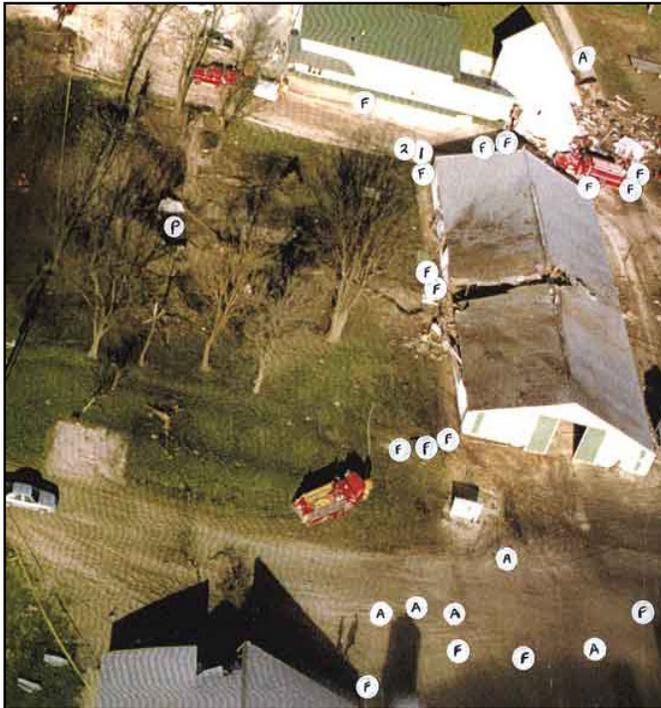
Left photo, Aerial view of Incident scene showing locations of firefighters and equipment at time of explosion, from NIOSH report at <http://www.cdc.gov/niosh/fire/reports/face9814.html>.

P = position of propane tank
 1, 2 = location of firefighters killed by fragments from exploding propane tank
 F = position of other firefighters
 A = position of apparatus

3. Firefighters were too close to the propane tank. The firefighters assumed that if they kept away from the ends of the propane tank they would be safe. The CSB report cited that firefighters had receive inadequate training for responding to propane tank fires.

1. Do not assume that the venting of propane from relief valves will prevent over pressurization and rupture of the tank.
2. Apply large quantities of water to the tank. For large propane tanks, at least 500 gallons per minute is needed.
3. If a flame is impinging on the tank, water must be applied directly to the impinged area in order to prevent a BLEVE.

4. Water should be sprayed by use of an unmanned fire hose system.
5. If a continuous supply of water is not available, withdraw and isolate the area for ½ mile in all directions.

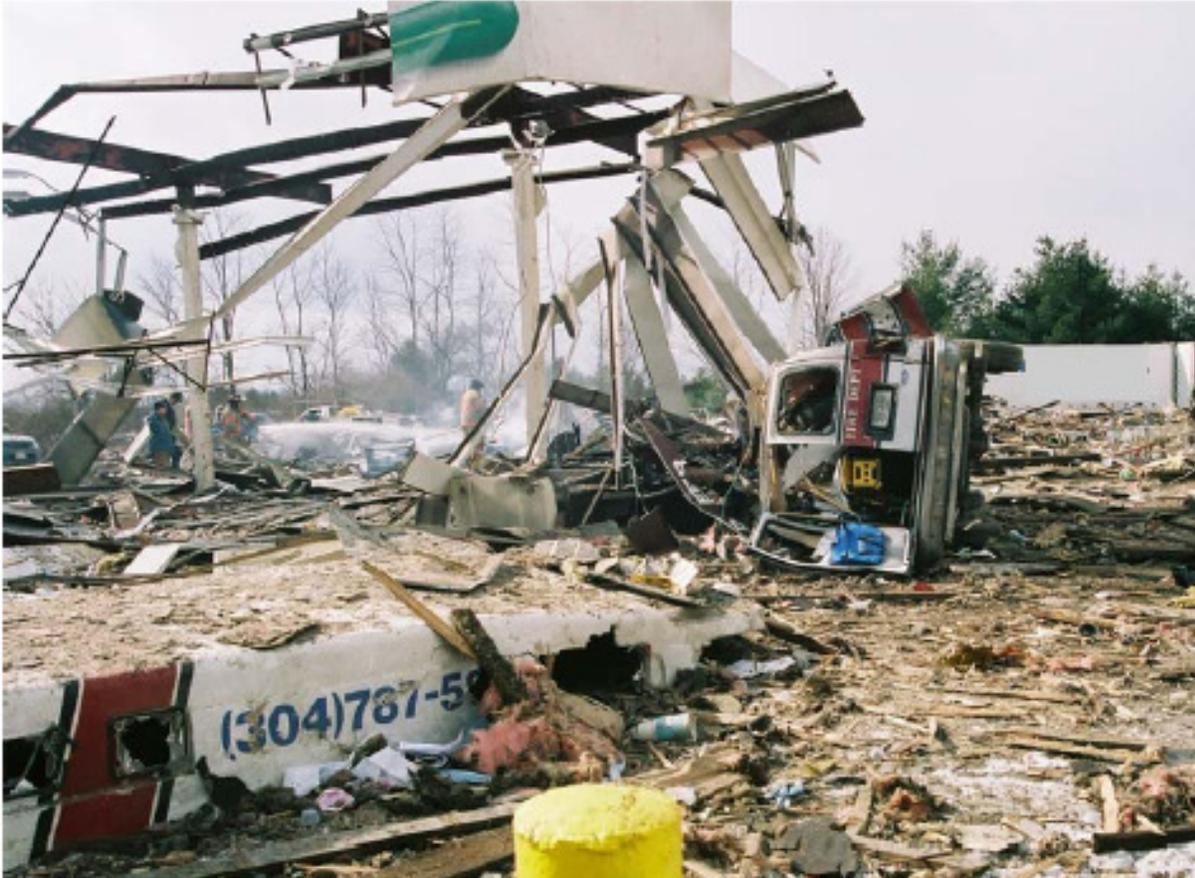
Photo from West Virginia State Fire Marshall as used in CSB report

The above photo, taken from CSB report no. 2007-04-I-WV, shows the demolished store and ambulance caught in the propane explosion.

Unlike the Herrig Brothers Albert City explosion, this did not involve a tank BLEVE. The cause was a propane leak which resulted in propane concentration in and near the store to build up and exceed the lower explosive limit concentration in the air (>2.1% by volume of propane in air).

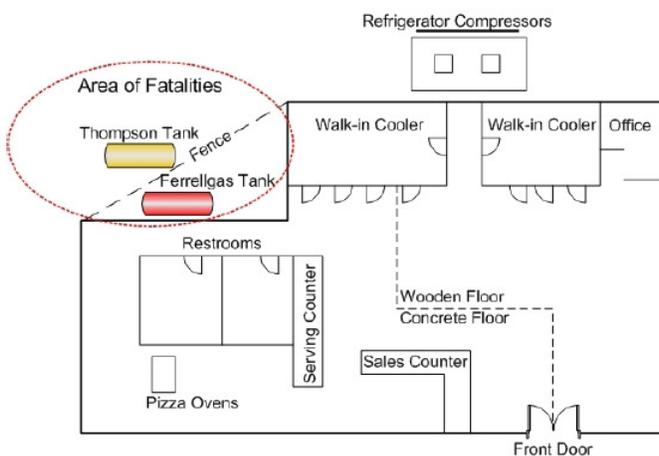
The propane leak occurred during transfer operations, when propane was being transferred from an existing older tank owned by Ferrellgas to a newly installed tank owned by Thompson Gas and Electric Services (called the Thompson tank). The two tanks were located adjacent to The Little General Store, as seen in the sketch to the left. The propane tanks were each 500 gallon capacity. The new Thompson tank was to be installed 10 feet from the building but the older tank was right next to the building.

1. The Ferrellgas Propane Tank, installed in 1994, was located right next to the building in contrary to OSHA and National Fire Protection Association (NFPA) Standards which state that a 500 gallon propane tank should be located at least 10 feet from commercial or residential buildings. The OSHA standard, *Storage and Handling of Liquefied Petroleum Gases*, and NFPA 54, *National Fuel Gas Code*, and NFPA 58 Chapter 6, *Liquefied Petroleum Gas Code*, all address the location of tanks. The open building overhang above the propane tank, and the interior restroom exhaust ducts provided a direct pathway for propane gas to enter the store. It was not clear to CSB why this shortcoming was not recognized and corrected during the 12 or 13 years the tank was in service, even though it was filled many times and inspected. Another propane company prior to Ferrellgas had originally installed the tank. The new Thompson tank was to be located 10 feet away from the store.

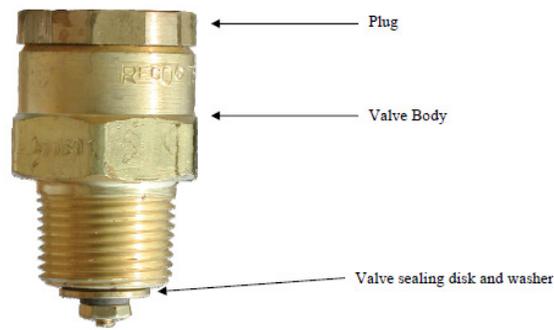
Top: Liquid Withdrawal Valve
Left: Removed Plug, with telltail circled

3. Technicians only open liquid withdrawal valves when propane tanks are completely emptied of liquid. The CSB investigation found that the liquid withdrawal valve was still on the damaged tank after the accident, but the plug was removed. The investigation found that the liquid withdrawal valve itself was defective causing it to be in an “open position”, and assuming the valve was defective before the accident, this means that the plug was the only thing preventing the propane from escaping the tank. As an additional safety backup, the plug on the withdrawal valve has a telltale drilled through the treaded portion which should have released a small stream of propane once the plug was partially backed out in the case of a defective valve in open position. This should have alerted the

junior technician that the valve was leaking and something was wrong. This specific information was addressed in CETP training, which included written instructions, and which included the statement, “WHEN IN DOUBT DO NOT REMOVE THE PLUG”. The junior technician apparently did not recognize this and continued to unscrew the plug.
