## Methyl Isocyanate

### **August 2008 Bayer CropScience Explosion in West Virginia, 2 killed**

#### The Explosion at the Bayer Methomyl Production Facility:

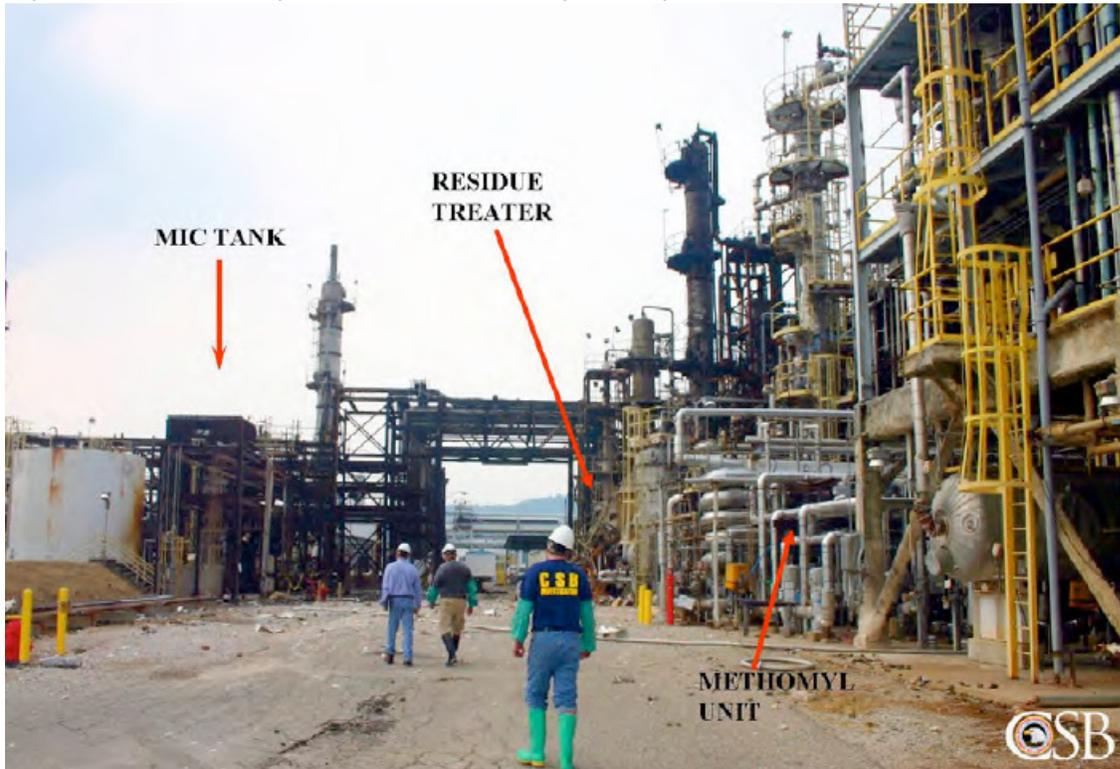
Figure 1: Relative locations of methyl isocyanate(MIC) tank, the residue treater which exploded, and methomyl production unit. A Chemical Safety Board investigator is in the foreground.

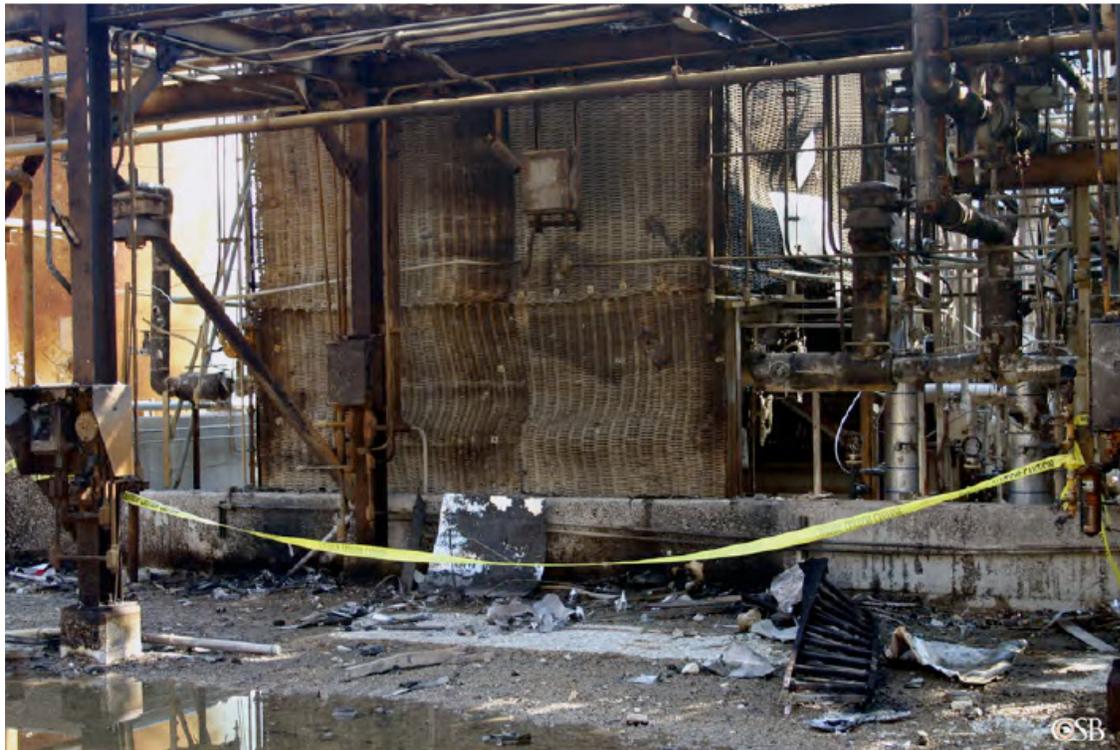
Figure 2: The blast blanket protecting the MIC tank. Note explosion debris in the foreground. Both illustrations from the CSB report on 21 April 2009 to the House Committee cited earlier.

operations. In 1982, Union Carbide equipped the tank with a protective “blast blanket”, which is a steel mesh which hangs from a steel framework presumably to protect the tank from accidental process-related explosions. Union Carbide sold the complex in 1986 following the Bhopal disaster. Pesticide production continued, and in 1994 the owner Rhone-Poulenc installed a second section of the blast blanket on top of the methyl isocyanate (MIC) tank. Bayer acquired the complex in 2002 and continued pesticide production and has more than 500 employees at the site.

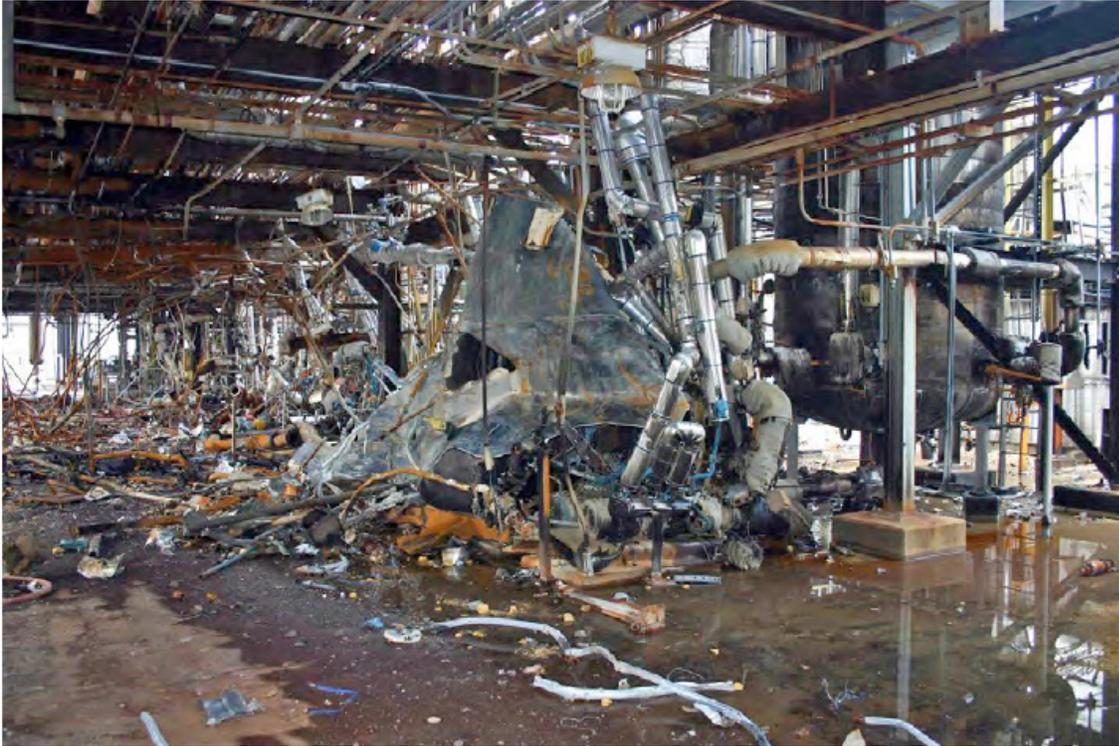
Figure 3. Path of destruction caused by careening residual treater vessel, which came to rest as shown in the center of the picture (from CSB 21 April 2009 report). The residual treater is designed to decompose waste methomyl in a solvent carrier before final incineration.

Earlier, the plant had installed new and completely different computer control equipment for the methomyl production area. On the night of the explosion, the control room operator saw unexpected, rapidly rising pressure displayed on the control console for the residue treater vessel. He asked outside operators to investigate for a possible blockage of the residue treater vent line. As operators approached the equipment, at 10:30 PM, the vessel relief valves were already relieving excess pressure but could relieve the pressure fast enough. Without warning, the residue treater vessel suddenly ruptured, ejecting as much as 2500 gallons of highly flammable liquid. The 5500 pound residue treater vessel careened northeast into the

methomyl production area destroying steel columns, piping, and equipment along the way. By fortunate chance, the vessel did not slam into the MIC tank located 80 feet away from the explosion. The two operators were killed by the explosion.

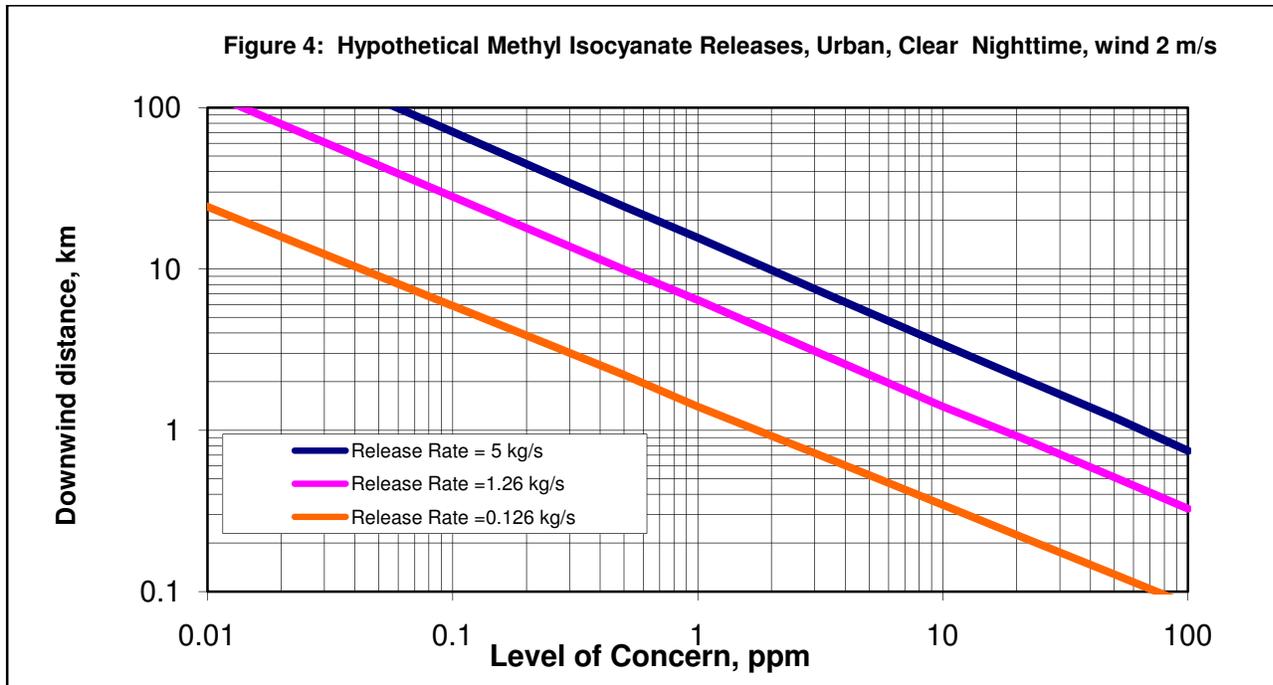
At a 21 ppm level of concern, the PEAC tool predicts this occurs at a downwind distance of 892 meters (0.892 km; about 0.6 miles). This concentration is lethal. The 21 ppm concentration is at the toxic cloud centerline near ground level. However, if we are looking at the AEGL-2 level of concern for one-hour exposure (0.067 ppm), a protective action distance of 36.3 km is predicted. We can rerun the PEAC tool at different levels of concern and plot the distances as a function of the levels of concern. We will repeat the exercise for a 5 kg/s methyl isocyanate release and for a 0.126 kg/s methyl isocyanate release. The results are shown in figure 4. Note that the scale is logarithmic.

The 5 kg/s release is equivalent to the average release rate if 27 metric tonnes of methyl isocyanate is released in 1.5 hours. The 1.26 kg/s release is the average release rate if 10,000 lbs is released in one hour. The 0.126 kg/s release is the average release rate if 1000 lbs is released in one hour.

The modeling illustrated by figures 4 and 5 represent concentration levels near the ground and at the toxic cloud centerline. As one moves crosswind away from the centerline, modeling

Singh and Ghosh attempted to model the Bhopal toxic gas plume cloud. Their results are available in J. Hazard. Mat. Vol 17, pp1-22 (1987). An updated paper can be purchased from [http://www.sciencedirect.com/science?\\_ob=ArticleURL&\\_udi=B6VHC-3SWKV74-2&\\_user=10&\\_rdoc=1&\\_fmt=&\\_orig=search&\\_sort=d&\\_docanchor=&\\_view=c&\\_searchStrId=1032754613&\\_rerunOrigin=google&\\_acct=C000050221&\\_version=1&\\_urlVersion=0&\\_userid=10&md5=d2a3628b761056d21c9c6689674502ba](http://www.sciencedirect.com/science?_ob=ArticleURL&_udi=B6VHC-3SWKV74-2&_user=10&_rdoc=1&_fmt=&_orig=search&_sort=d&_docanchor=&_view=c&_searchStrId=1032754613&_rerunOrigin=google&_acct=C000050221&_version=1&_urlVersion=0&_userid=10&md5=d2a3628b761056d21c9c6689674502ba). Based on 27 tonnes of methyl isocyanate released during 1 to 2 hours, they estimated a range of concentrations varying from 0.12 to 85.6 ppm over the 40 kilometer square area of the plume cloud where people were exposed. This release is approximated by the 5 kg/s release in figures 4 and 5.

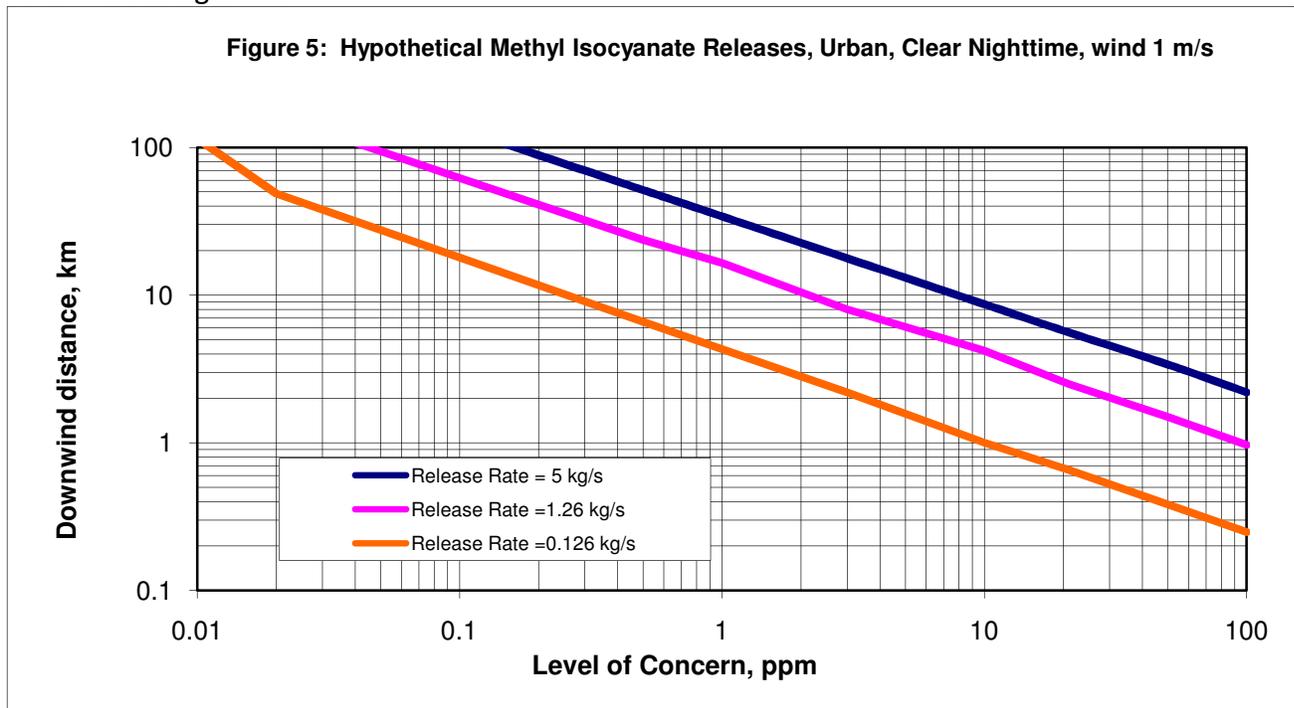
The wind speed also makes a difference, especially under clear skies and during nighttime. The air becomes even more stable. We can repeat the same exercise for a 1 m/s wind speed. The results are in figure 5.
