## Real-World Explosions and Fire Examples: Part 2

### **Ammonium Perchlorate Explosion and Fire, Henderson NV, 1988, 2 killed, 372 injured**

### **Hydroxylamine Explosion, Lehigh Co., PA, 1999, 5 Killed, 14 People Injured**

### **Fire and Community Evacuation, Apex, North Carolina, 2006, No deaths, 30 people Sought Medical attention**

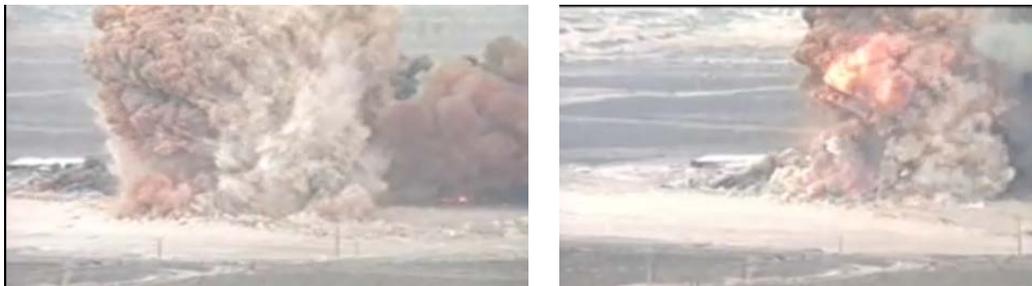
Top: You-Tube video clip taken by a television engineer less than a second after the largest detonation (shock wave boundary line defined by white/black areas).

A television engineer doing maintenance on a television tower at a nearby hill 2 miles away caught the explosions and fireball on tape. The video footage has been widely shown, and it captures the shock wave for the largest explosion. The video footage is available at YouTube and MySpace and elsewhere at several web sites:

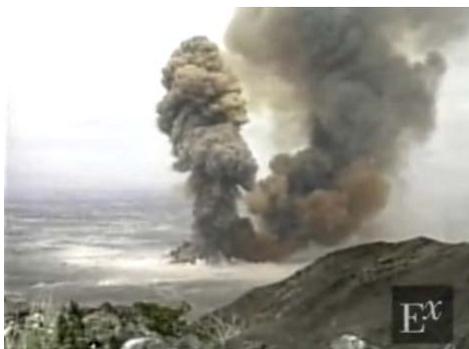
Both the PEPCON facility and the Kidd & Co. facility were completely destroyed by the explosions and fires. The explosions created a crater 15 feet deep and 200 feet long in the ammonium perchlorate storage area. The largest explosion was equivalent to 1000 tons of TNT. Broken windows, doors blown off, and injuries from flying glass were reported up to 10 miles away. Moderate structural damage to buildings was reported 3 miles away. A Boeing 737 on final approach at McCarran International Airport, 7 miles away, was buffeted by the shock wave; windows were cracked and doors pushed open at the airport. The incident caused over \$100 million in damages. Bankrupted PEPCON settled for \$71 million in a courtroom battle involving dozens of insurance companies and over 50 law firms.

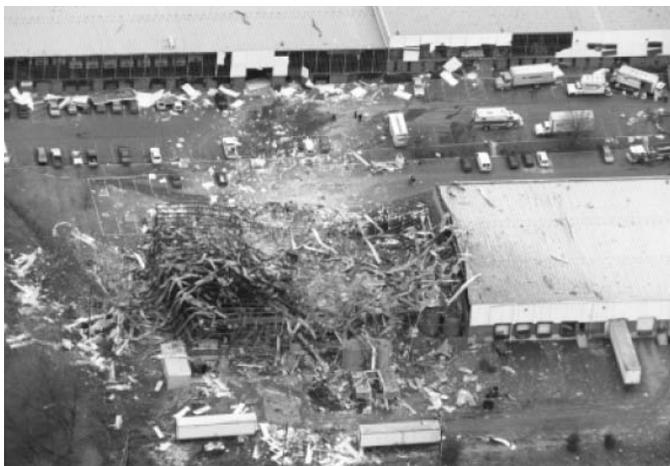
Photo by Tom Volk, "The Morning Call", used in the CSB Report

On 19 February 1999, at 8:14 PM, a process vessel containing several hundred pounds of hydroxylamine exploded at the Concept Sciences, Inc. (CSI) production facility in the Lehigh Valley Industrial Park near Allentown, PA. Four CSI employees and one employee of an adjacent business were killed; 14 people were injured including six firefighters. The incident occurred during startup of a new production facility for this chemical. The CSI facility was located close to other commercial buildings which were damaged by the blast.

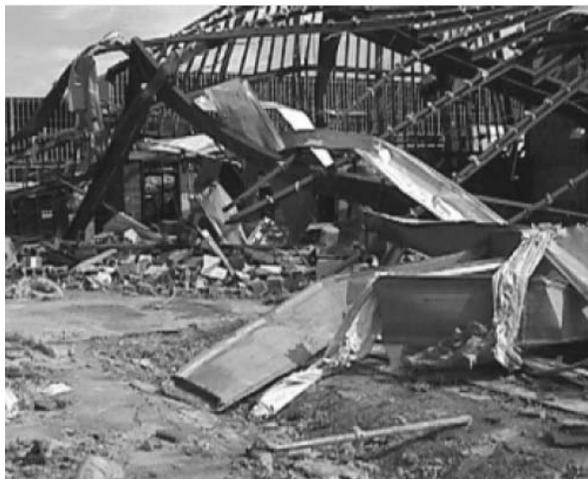
Building damage at charge tank area, from CSB report

The explosion damaged 10 buildings within the Lehigh Valley Industrial Park and several residences. Total property damage was estimated between \$3.5 and \$4 million. Sections of the distillation equipment were thrown more than 1000 feet. The end manway of the charge tank was thrown 200 feet. A crater approximately 6 feet wide, 26 feet long, and 16 inches deep was found in the concrete floor where the charge tank had been located.

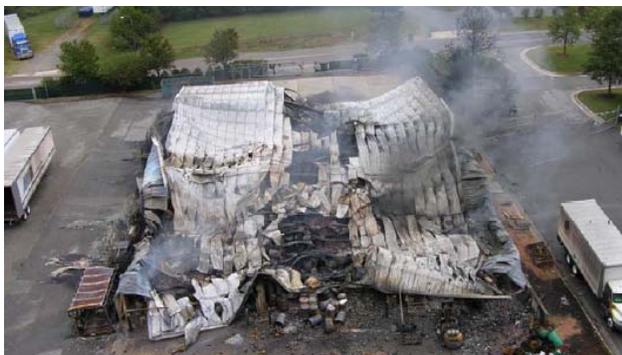
Photo from Wake County Fire/Rescue Services used in CSB Report of destroyed Environmental Quality Company facility. Notice stacked drums.

The firefighters located the source as coming from one of the hazardous waste bays at the EQ facility. The facility itself was vacant and was protected by a chain-like fence with a padlocked gate. A small “sofa-sized” fire was in the bay. However, the fire grew and spread to the flammable hazardous liquid storage area in the next few minutes causing 55-gallon drums to ‘explode” sending fireballs hundreds of feet into the air. The EQ facility eventually collapsed as seen in the photo. About 30 people including 13 first responders sought medical attention at local hospitals for respiratory distress and nausea, although none were admitted.

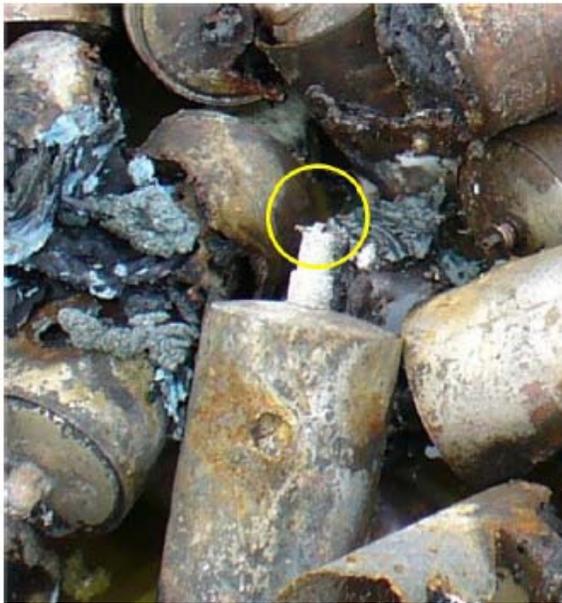
Photo, from Chemical Safety Board Report showing an oxygen generator with activation pin circled, in EQ rubble

While the CSB never determined the cause of the EQ fire at Apex, North Carolina, the fire did originate in the bay where oxidizers were stored. Included in the oxidizer bay were unspent aircraft oxygen generators and containers of solid chlorine-based pool chemicals. The CSB report said that if EQ used fire barriers (walls) to separate the segregated bays, the fire likely would have been contained within the oxidizer bay and not spread to the bay where flammable hazardous wastes were stored. In addition, the EQ facility did not have an active fire suppression system and relied only on five portable fire extinguishers for control or to extinguish fires even though the facility stored hundreds of drums of flammable and combustible materials. The building was unoccupied at the time of the incident.
