Propane Fires and Explosions

Turkey Farm, Albert City Iowa, 9 April 1998. Two fire fighters killed, seven injured

Propane Explosion, 30 January 2007, Ghent WV, Four killed including two responders, six injured

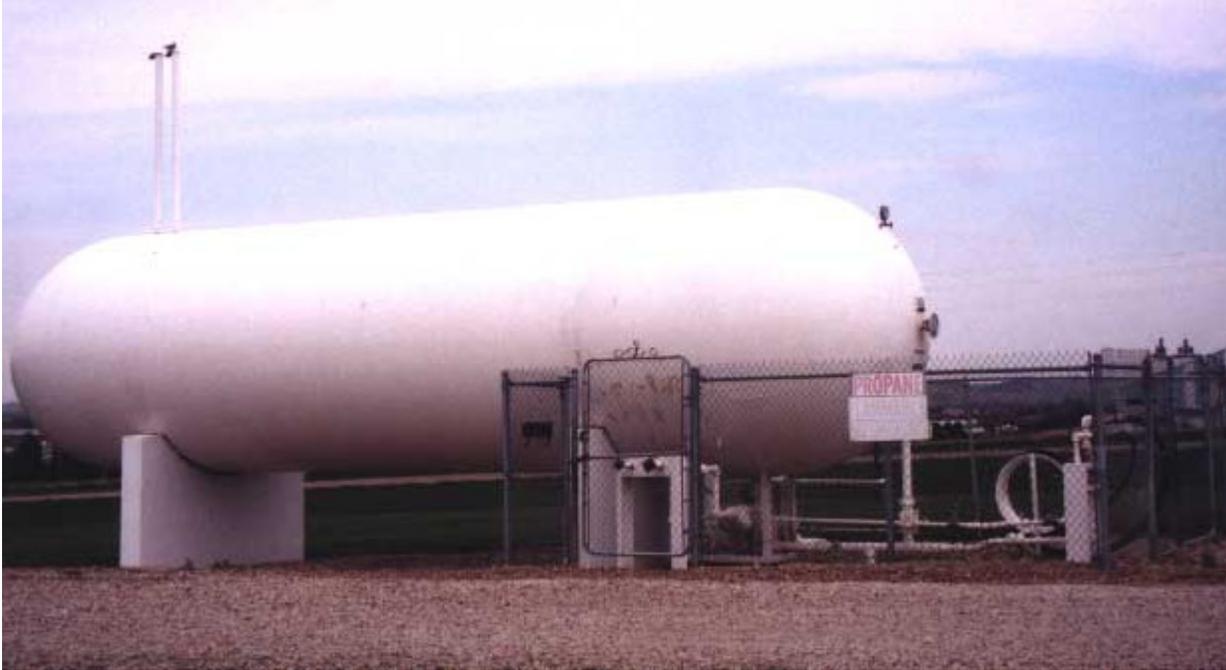
Top, A 18,000-gallon propane tank similar to the one that exploded at the Herrig Brothers Feather Creek Farm (the turkey farm) in Albert City, Iowa, from NIOSH report. Note protective fencing around piping for this tank which was lacking at the Iowa farm propane tank.

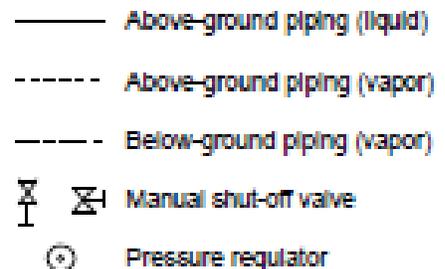
The following is a sketch of 18,000-gallon propane tank and piping setup at the farm, from the CSB report. The tank was estimated to contain 10,000 gallons of propane at the time of the explosion, at approximately 11:28 pm, on April 9, 1998. Two firefighters responding to a fire which engulfed the propane tank, were killed by tank fragments resulting from a BLEVE explosion (BLEVE= Boiling Liquid Expanding Vapor Explosion). Seven other people were injured, and several buildings were severely damaged by the blast. The firefighters assumed if they stayed away from the ends of the tank they would be “safe”, but exploding tank fragments were hurled in all directions.

1. The above ground piping was not protected from potential damage by vehicles, as required by Iowa law citing the 1979 edition of the National Fire Protection Association’s “Standard for the Storage and Handling of Liquefied Petroleum Gases” (NRPA 58). The lack of piping protection allowed the ATV to crash into the pipes that ran from the tank to the vaporizers.

2. The outlet propane pipe diameter was improperly sized for the excess flow valve, which was supposed to automatically shut off the flow in case of excess flow in the propane pipe. The valve was designed to shut off at 200 gpm, which in no way could occur with the ¾ inch diameter propane outlet pipe. Therefore the valve did not shut off. Had the valve shut off, the BLEVE probably would not have occurred.

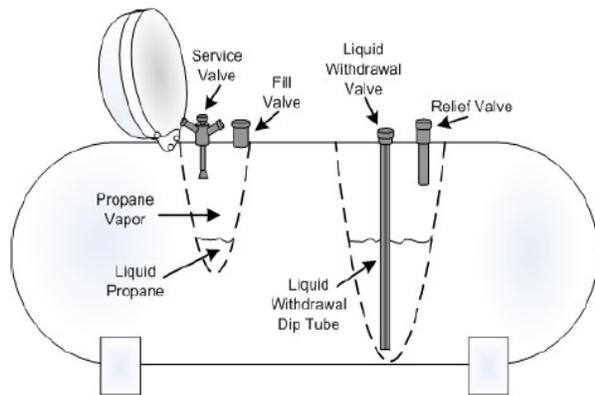
Sketch of a propane tank showing locations of Liquid Withdrawal Valve and Fill Valve

3. Technicians only open liquid withdrawal valves when propane tanks are completely emptied of liquid. The CSB investigation found that the liquid withdrawal valve was still on the damaged tank after the accident, but the plug was removed. The investigation found that the liquid withdrawal valve itself was defective causing it to be in an “open position”, and assuming the valve was defective before the accident, this means that the plug was the only thing preventing the propane from escaping the tank. As an additional safety backup, the plug on the withdrawal valve has a telltale drilled through the treaded portion which should have released a small stream of propane once the plug was partially backed out in the case of a defective valve in open position. This should have alerted the

junior technician that the valve was leaking and something was wrong. This specific information was addressed in CETP training, which included written instructions, and which included the statement, “WHEN IN DOUBT DO NOT REMOVE THE PLUG”. The junior technician apparently did not recognize this and continued to unscrew the plug.
